## Distress in the old brick masonry bridges of Bangladesh Railway and remedial measure with a new approach - a case study

M. H. Rahman<sup>1</sup> M. Z. Alam<sup>2</sup>, K. N. Mim<sup>3</sup>

<sup>1</sup>Additional Chief Engineer, Bridge (East), Bangladesh Railway ([hrahman\\_2000@yahoo.com](mailto:hrahman_2000@yahoo.com))

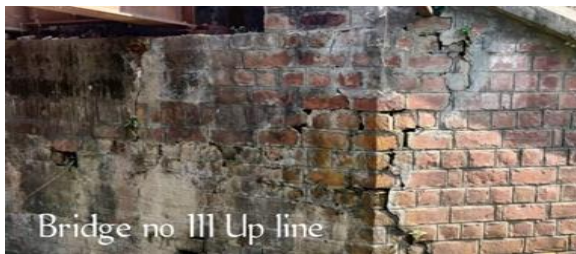
a) Cracks in Bed block, abutment, and wing wall (111up)

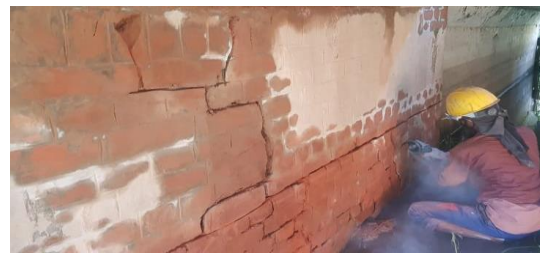
b) Horizontal and vertical cracks in Abutment (221 up)

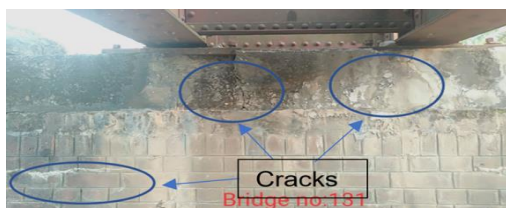
d) Cracks in Pier wall and Bed block (131 up)

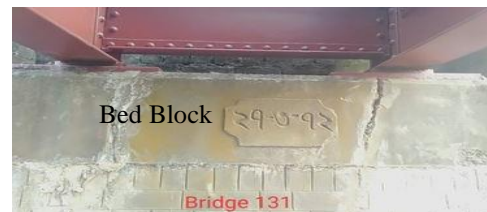
d) Cracks in Bed block (Bridge No. 131 dn)

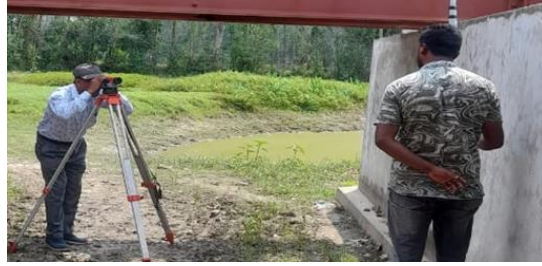
Figure 7 Measurement of Settlement of Bridge No. 131 (up) on 15.06.2023

The bridges repaired in this case study are monitored regularly and searched for new crack development at two months intervals and the settlement is monitored at six months intervals, recorded subsequently. For the measurement of settlement, corresponding benchmarks are installed at each bridge. For each bridge, two benchmarks are installed during repair work, and the height of the top surface of the bed block is measured with the concerned benchmark by the leveling machine and recorded accordingly (**Error! Reference source not found.**). Such measurement is taken at every six-month interval and recorded to investigate the settlement. During these observations, no settlement is recorded and no crack is observed since repair work is done on those bridges. However, angular cracks are observed in the wing wall of bridge no.209, not in the repaired location but about 1.5 feet away six months after the completion of the repair work. After careful observation and analysis, the reason is identified as the settlement of the wing wall's foundation. So that particular wing needs to be re-constructed. As mentioned earlier cracks and other distress in bridges are repaired first, then are covered by RCC Jacketing at different times. Therefore, the repaired surface of all the bridges was uncovered before RCC Jacketing work nearly for a year but no visual cracks were identified during the inspection, neither along the previous crack nor in other areas. Moreover, for Bridge no 210(up) and 221(up) without RCC jacketing, three years have already passed from the completion of the repair work to the last inspection, and still no visual cracks or distortions and settlements are recorded. This indicates that the foundations of the bridges are intact, and no settlement is encountered which also reveals that RCC Jacketing may have been avoided.
